**RUSSELL ELSEY DAM
WASHINGTON COUNTY, MISSOURI
MO 30102**

**PHASE 1 INSPECTION REPORT
NATIONAL DAM SAFETY INSPECTION**

PREPARED BY: U.S. ARMY ENGINEER DISTRICT, ST. LOUIS

SEPTEMBER 1980

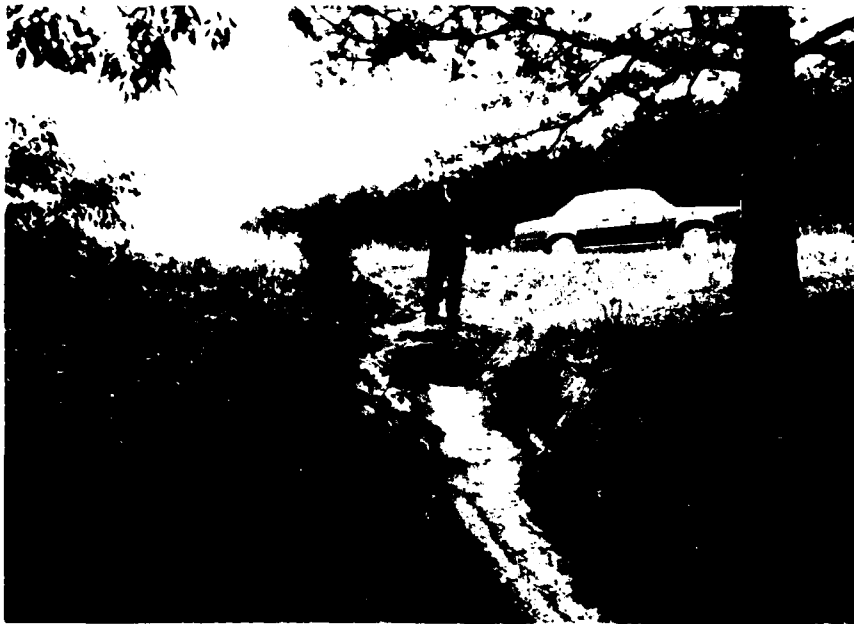
- h. Normal operating procedures. No operating records were found. Flood flows pass uncontrolled over the spillways. Normal pool elevation is controlled by two overflow pipes near the main spillway (See Photo 2).

4. Overflow outlets. Two pipes (one 12-in. and one 14-in. diameter) near the main spillway inlet serve to regulate the normal pool elevation during periods of moderate inflow. A crude trash rack protects the inlet. The pipes and the concrete-lined discharge channel appeared to be in good condition.

2. Exit for low flow outlet and concrete-lined channel.
